Name of Project: Auke Lake Way Corridor Improvements & Reconstruction

Project Number: 2006-28

Re: UAS Campus Greenway Asphalt Pavement Inspection
R&M Project No. 091414.1

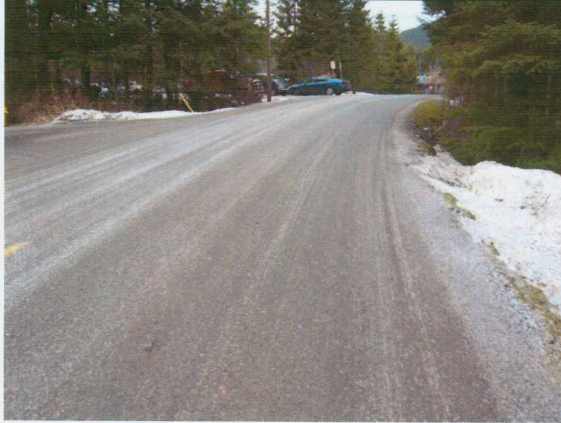
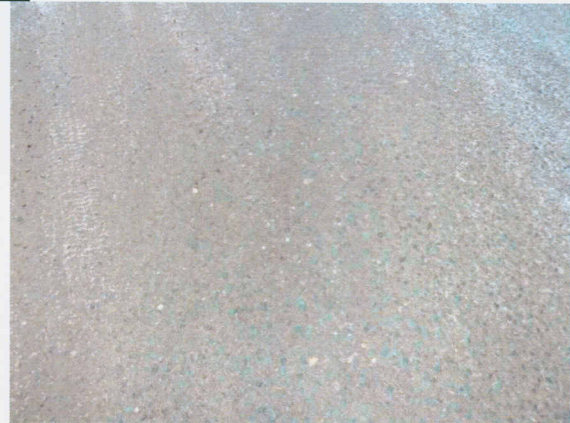
Sta. 0+00 to Sta. 0+224: Low severity polished aggregate distress type.

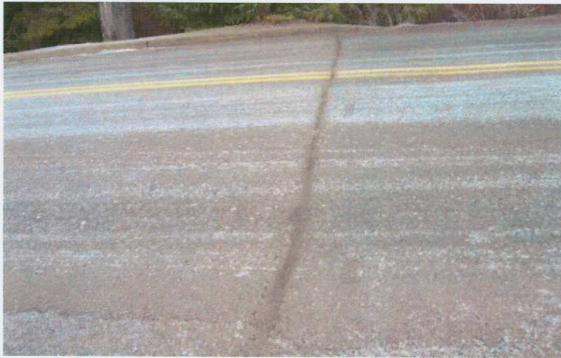
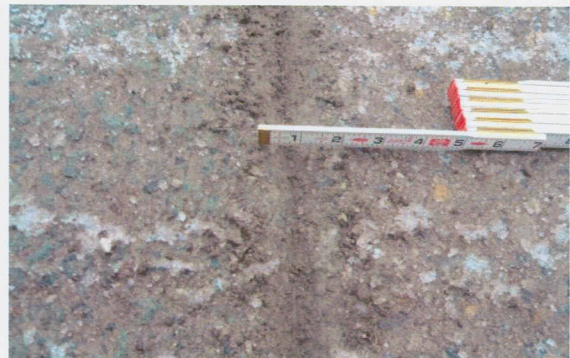
Sta. 0+224: Low to moderate severity transverse cracking at construction joint.

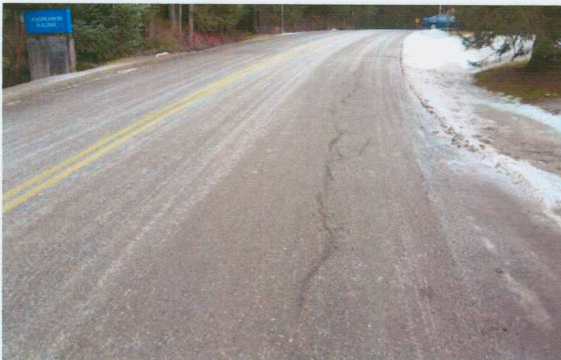
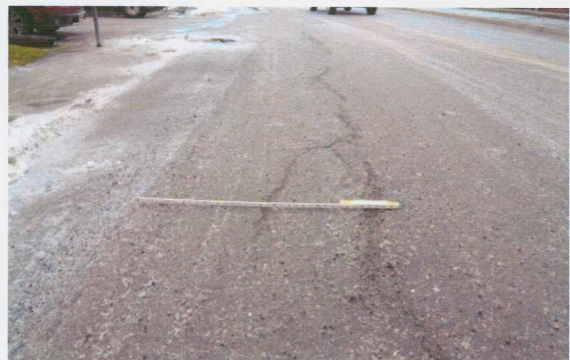
The visible pavement inspection revealed areas of pavement failure and potential subbase failure due to poor roadside drainage (0+230 to 0+350). Construction over the top of existing pavement surfaces that have shown low to moderate severity areas of failure, in our opinion, would lead to premature service life of new surface materials placed over the top of existing materials. The existing asphalt pavement surfaces are over 20 years old and nearly at the end of their useful service life. Existing failed pavement areas (cracking, settlement, potholes, etc.) should be removed and replaced. UAS Campus Greenway Improvements should include improvements to the base, subbase and roadside drainage prior to new materials being placed over the existing pavement surfaces.

Sta. 0+230 to 0+350: Moderate severity longitudinal cracking, most likely due to subbase failure and lack of drainage on uphill side of the road.

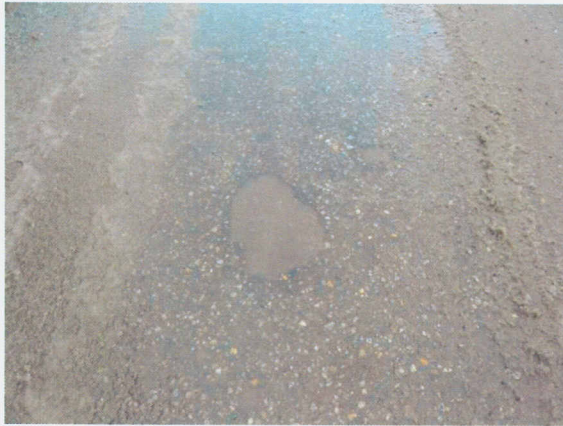
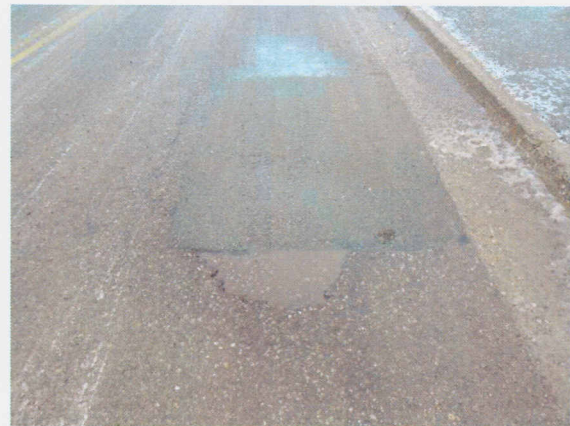
Sta. 0+323 to 0+425: Potholes and patching, moderate severity.

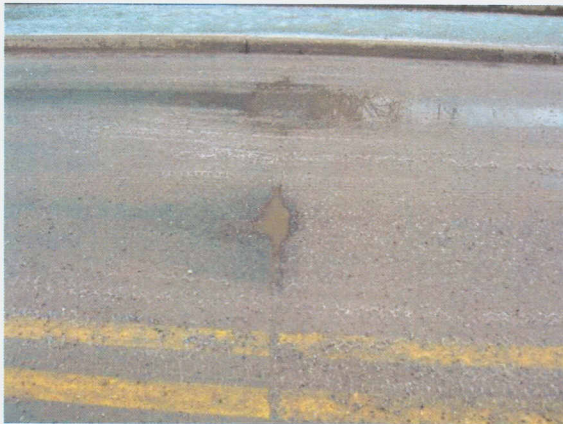
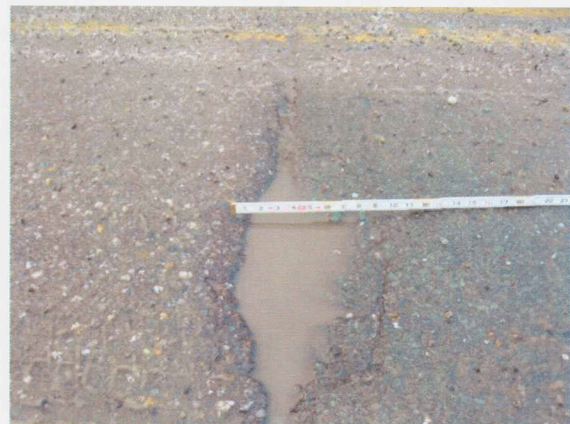
Sta. 0+323 to 0+425: Potholes and transverse cracking, moderate severity.

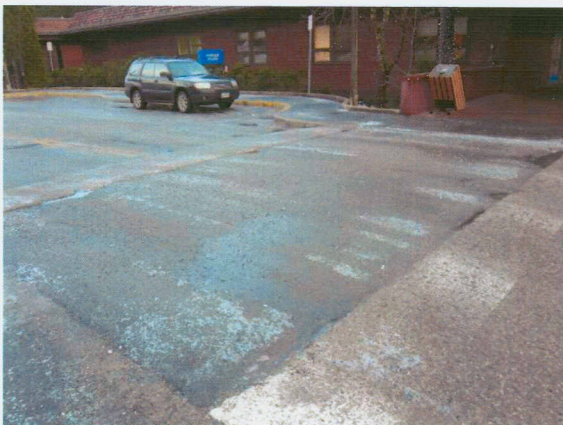
Sta. 0+425 to 0+440: Low severity depression at speed hump.

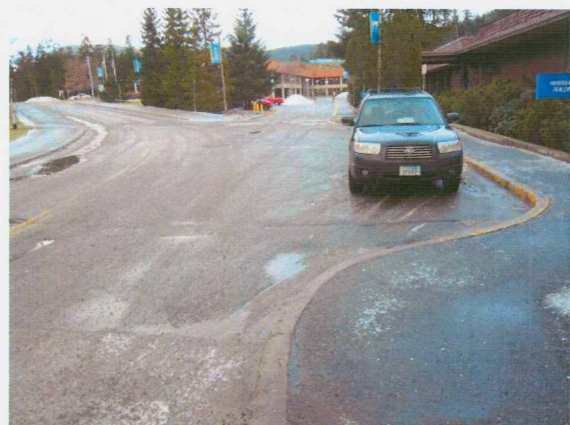
Sta. 0+425 to 0+528: Potholes, depression, transverse and reflective cracking, moderate severity.

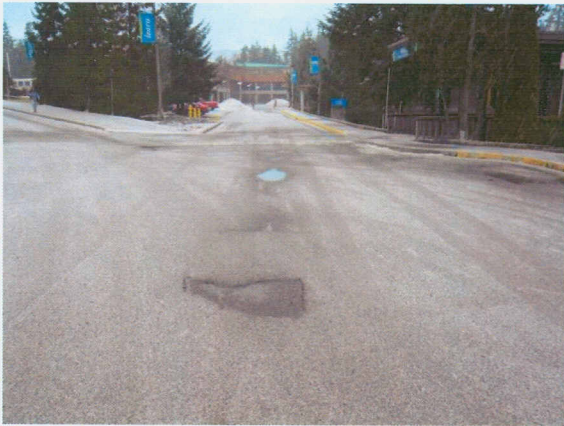
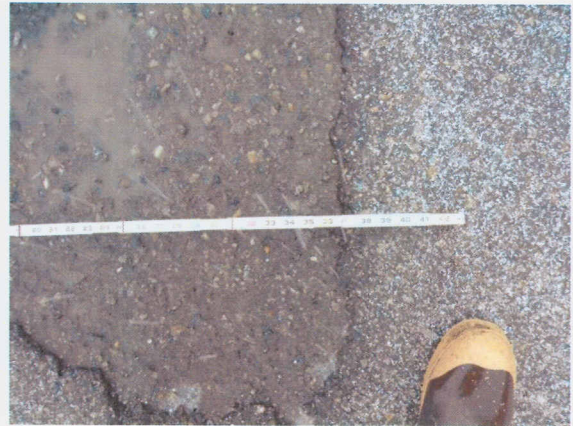
Sta. 0+425 to 0+528: Potholes, surface distortions and subbase settlement.

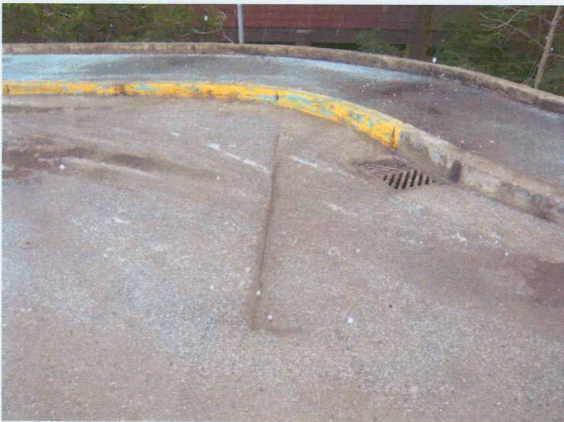
Sta. 0+425 to 0+528: Low severity transverse cracking at pavement joint.

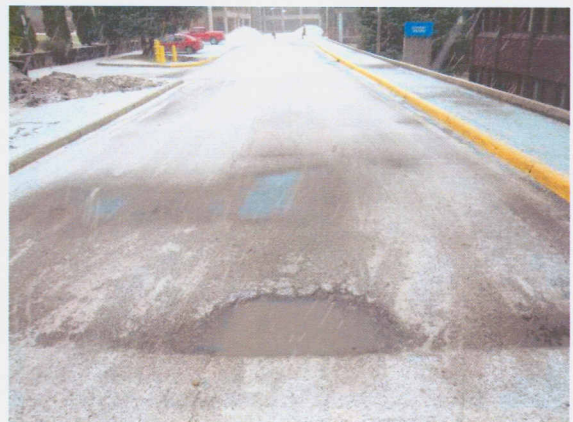
Sta. 0+535 to 0+580: Depression and settlement, center of road, low and moderate severity.

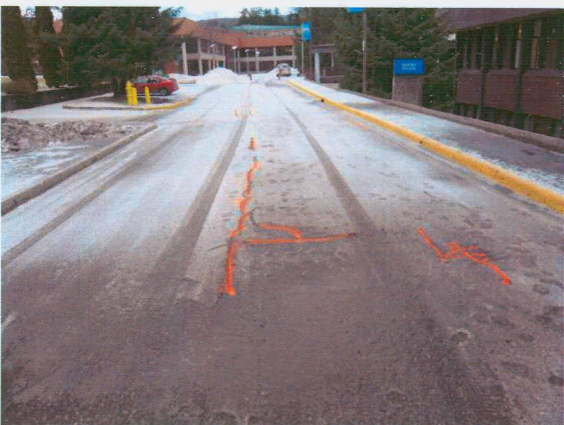
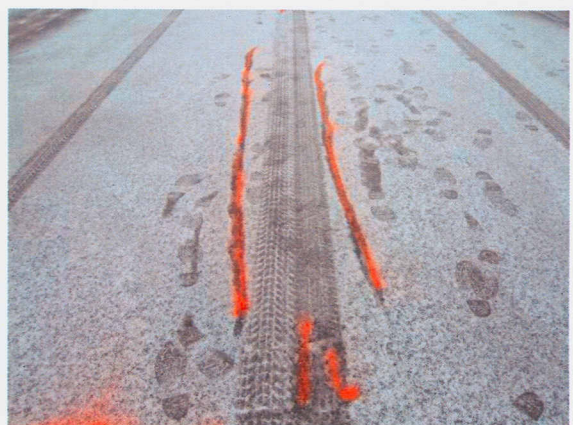
Sta. 0+580 to 0+730: Low to moderate severity longitudinal and transverse cracking

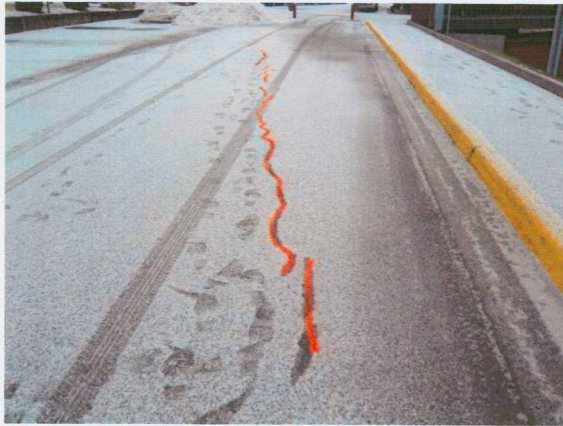
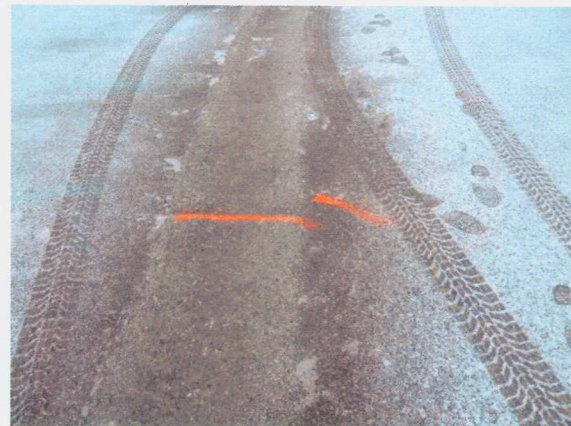
Sta. 0+580 to 0+730: Low to moderate severity longitudinal and transverse cracking

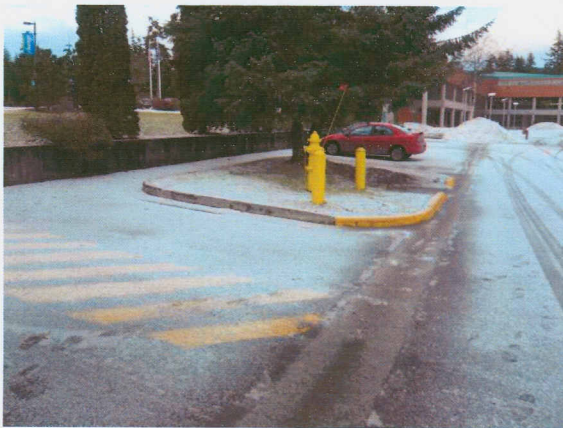
Sta. 0+580 to 0+730: Parking area with concrete valley gutter.

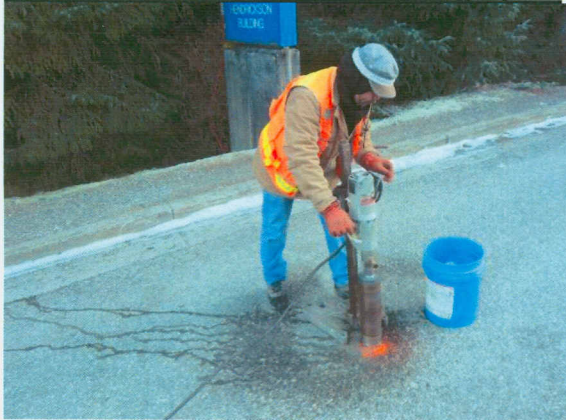
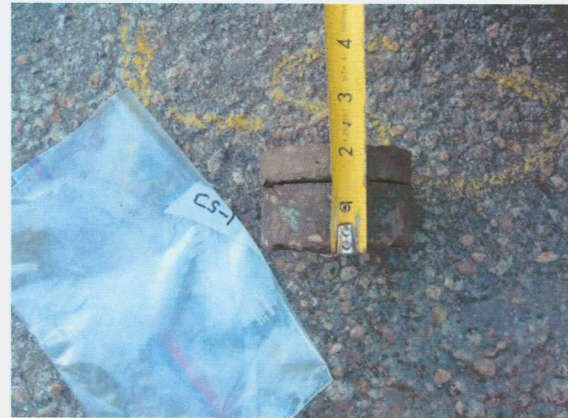
CS-1, Sta. 0+245 (right): Two layers of asphalt pavement with total thickness approximately 2". Top layer thickness is $\frac{3}{4}$ " while bottom layer is about $1\frac{1}{4}$ ".

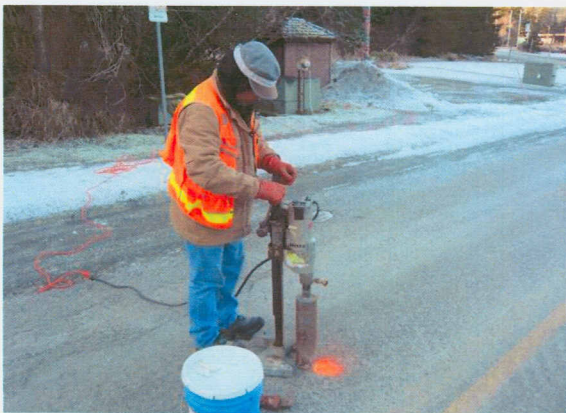
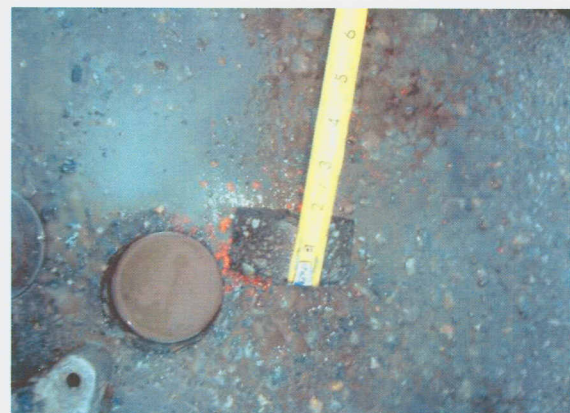
CS-2, Sta. 0+334.5 (left): Thickness of asphalt pavement is about $1\frac{1}{2}$ ".

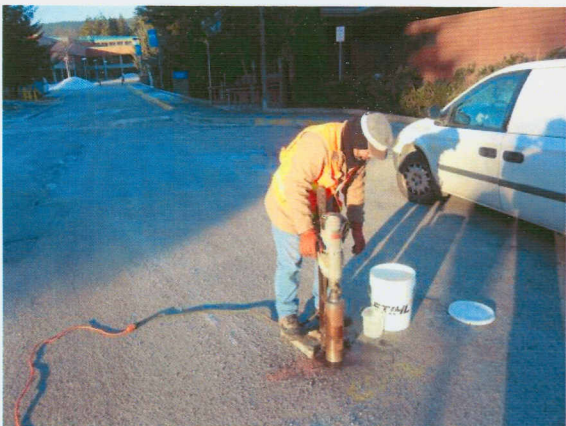
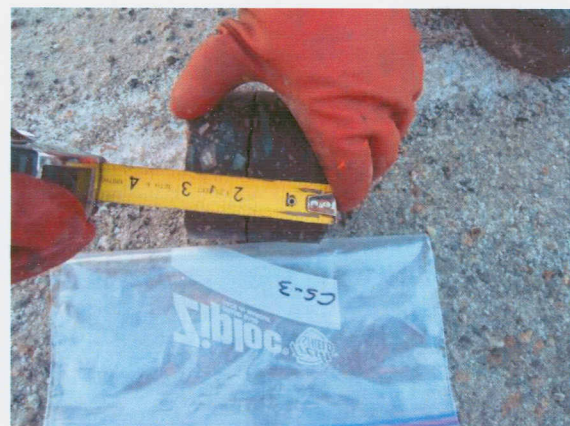
CS-3, Sta. 0+478 (right): Two layers of asphalt pavement with total thickness of approximately 2.75". Thickness of top layer is about $1\frac{1}{4}$ " while bottom layer is about $1\frac{1}{2}$ ".

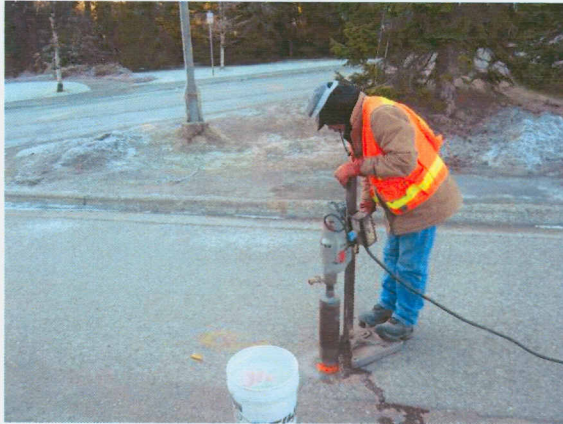
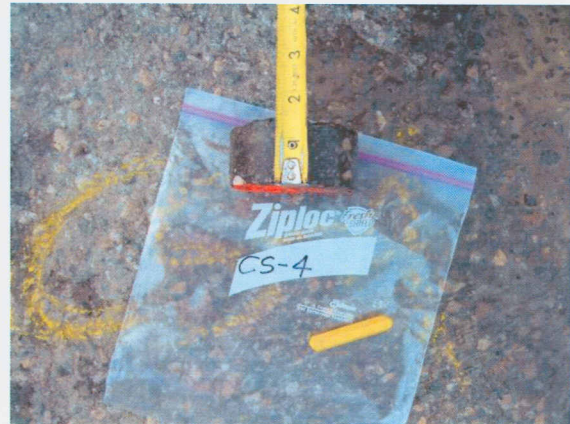
CS-4, Sta. 0+564 (near center): Thickness of asphalt pavement is about 1.3".

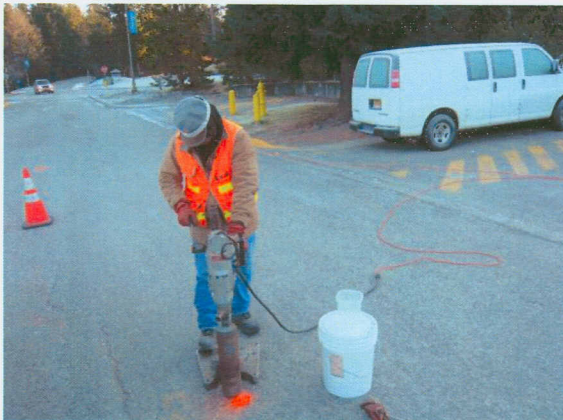
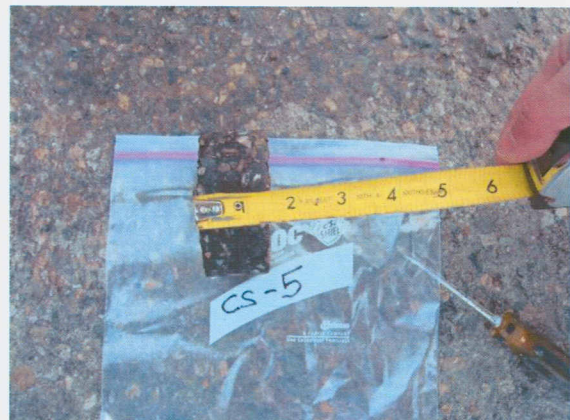
CS-5, Sta. 0+670.5 (near center): Thickness of asphalt pavement is about 1.4".
