A White Paper on Energy Use in Alaska's Public Facilities

Published 11/7/2012 | Version 1

Alaska
Housing
FINANCE CORPORATION

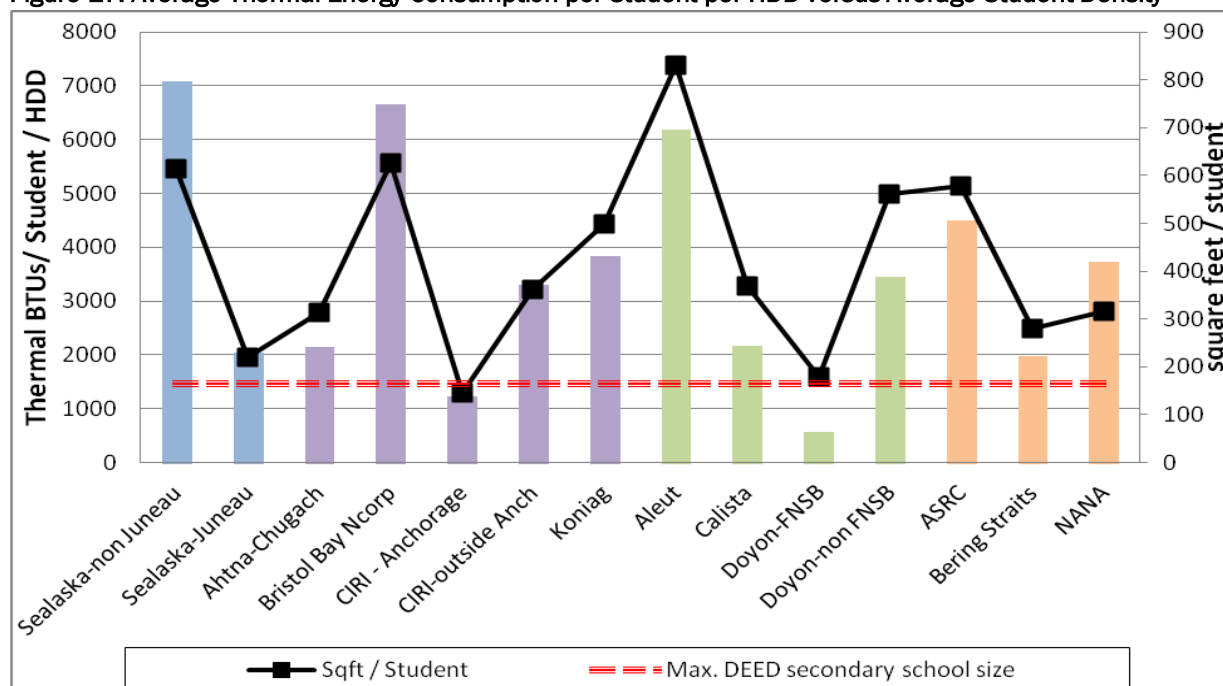
Figure 17: Average Thermal Energy Consumption per Student per HDD versus Average Student Density

It should be noted that DEED has a space allocation guideline that recommends a maximum limit on the gross square feet per student that can be built. As of 2005, the maximum square footage per student was 165 for secondary schools, and 114 for elementary schools¹⁸. Only audited schools in Anchorage and the Fairbanks North Star Borough meet these criteria, and the rest of the schools in the State have too large a school compared to the number of students—sometimes by a factor of 450 percent in excess of the standards.

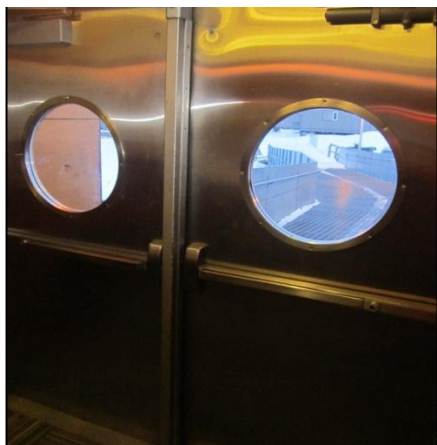
School A
 Primarily insulated wall on North side
 No classrooms with windows
 Few windows

- 7.25" Rigid Insulation
- Hot, sealed roof
- Well insulated metal doors with small windows.
- Arctic Entry

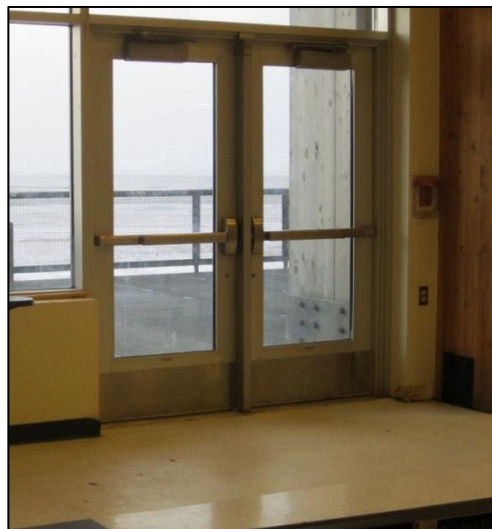
School B

- 5.5" rigid insulation
- Cold, vented roof
- Full glass metal doors
- No arctic entry

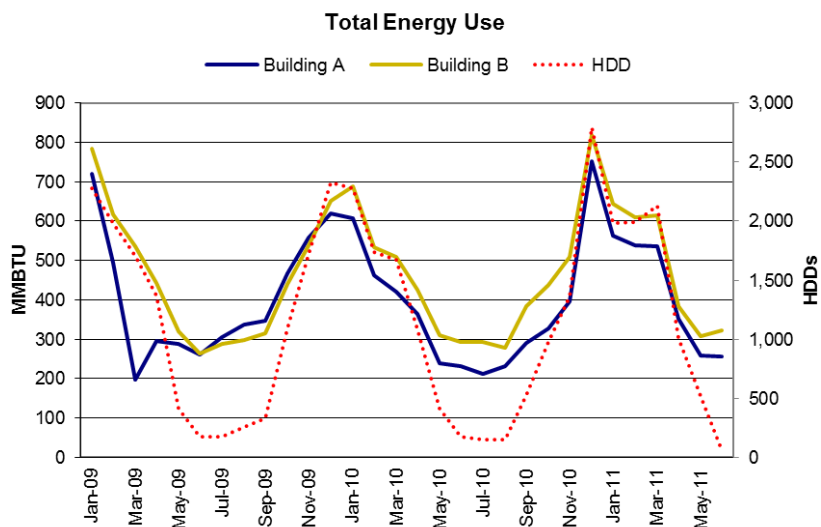
The graph below shows how energy use in the two buildings is affected by heating degree day (HDDs). The energy use trend almost perfectly follows the HDD trend in the winter months. The graph shows none of the apparent fluctuations of energy use that are normally seen from varying occupancy, building uses or schedules in normal buildings. This correlation of energy use and HDDs is an indication that primary energy use in these building is directly related to heating OSA that makes up for the excessive exhaust rates.

Cause Excessive levels of OSA are a byproduct of the buildings’ designs that use constant exhaust volumes as if each building were fully utilized on a 24/7 schedule. The designed exhaust rates require a high amount of OSA in

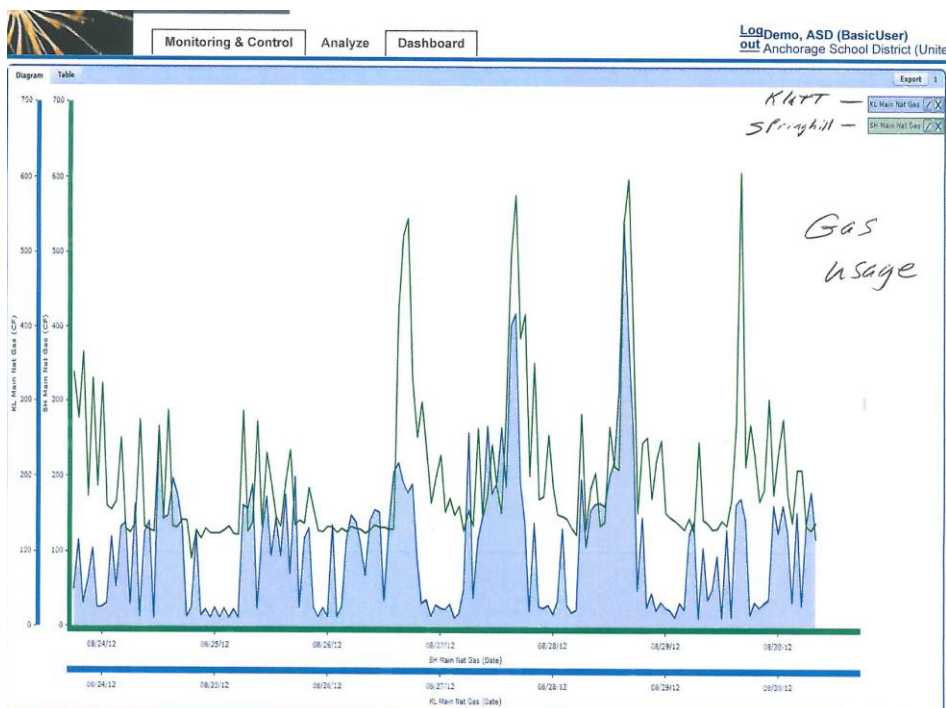
Figure 2.0: Gas Consumption for Klatt and Springhill Elementary Schools

Impact Klatt Elementary was provided with modern high-efficiency condensing gas boilers as a flagship project for ASD replacing 26 year old gas fired Weil McLain sectional boilers. From the utility data provided, the installation of these boilers and the degree of control provided by the DDC system has reduced the annual natural gas use of this building by 24.6 percent, based on the average annual consumption over the three-year periods of 2007-2009 and 2010-2012. Figure 1.0 shows the difference in natural gas used in Hundreds of Cubic Feet (CCF) and Annual Cost for Klatt Elementary’s natural gas usage over the three-year averages mentioned earlier. Cost savings over this period were shown to be \$9,945 annually, corresponding to a 21.5 percent reduction in actual cost paid for the natural gas used.

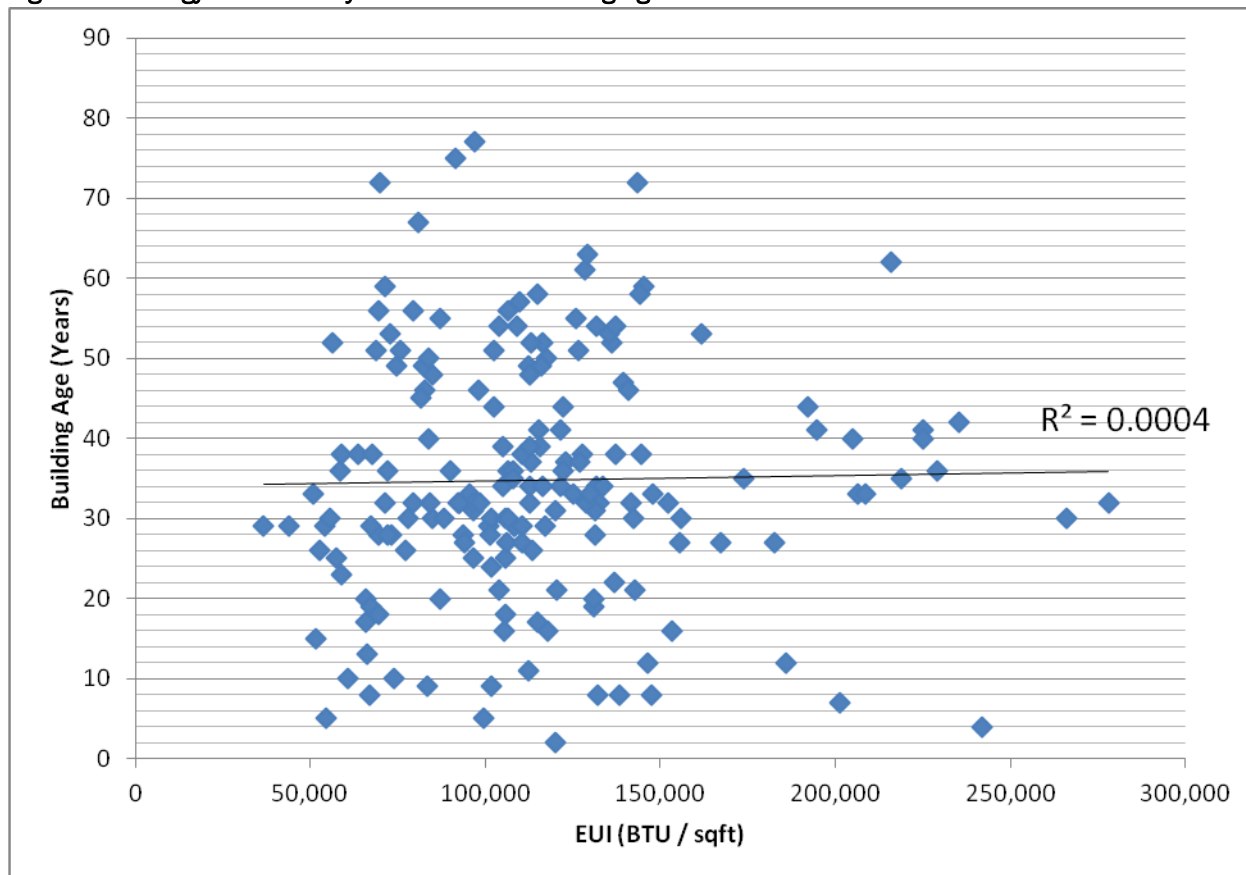
Figure 26: Energy Use Intensity of Schools vs. Building Age

An R² value of 1 indicates perfect correlation. In this case, the R² value of 0.0004 indicates very little correlation.

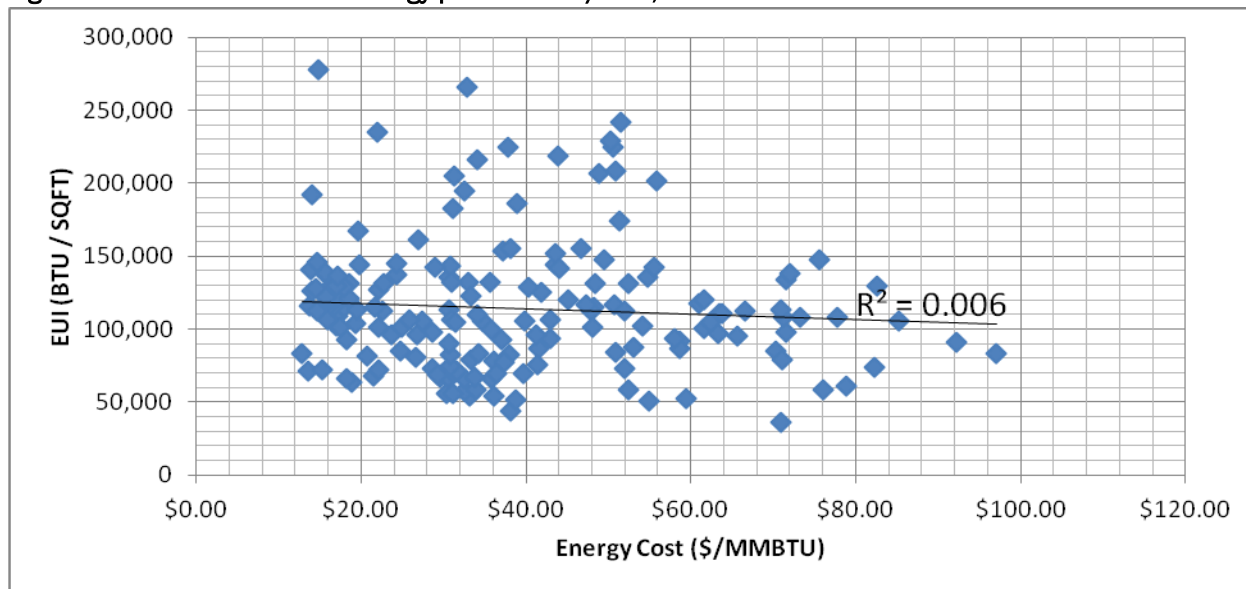
Figure 28: Correlation between energy price and EUI/HDD, Schools ONLY

Each point represents one of the audited buildings. An R^2 value of 1 indicates perfect correlation. In this case, the R^2 value of 0.006 indicates very little correlation.
